## **COLSON CASTER HEALS HOSPITAL CARTS: A Case Study of Customer Collaboration, Product Engineering, Testing, Delivery, and Service.**

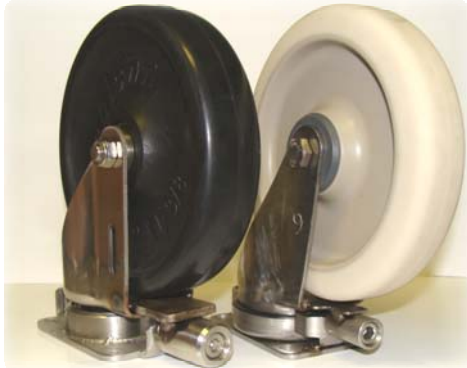
Colson Solution Left, Competitor Right

**Colson Tested, Designed and Tested Again.** Coming to agreement, as a group, as to what the issues were, provided the Colson team the confidence to immediately pursue explanations and determinations as to why the failures were occurring. Upon return to its facilities, Colson's troubleshooters were able to replicate the functioning environment of the hospitals and the demands of the wheels and carts. Following a sustained series of closely monitored run-throughs, it became apparent that the teams had accurately assessed the failures and that the rigors of the hospital environments were clearly more than the existing caster combination could ever have sustained. Test results were clear that the regular washing of the carts and then drying at temperatures reaching 290 degrees F was the culprit causing the plastic wheels to deteriorate and lose fidelity after each use and cleansing cycle. The caster's fork and passive swivel design was originally intended to allow straight, non-wobbling functionality and also feature a firm but light-weight swivel disengagement with only 4 lbs. of pressure for both human and AGV ease-of-use and mobility. Testing analysis revealed that upon continued use in the hospitals, the swivel became both hard to disengage, or disengaged when not appropriate with only minimal pressure. This failure in the operation of the fork and swivel mechanism was determined to be resulting from both a lightweight component design weakened by bends in the welds occurring during regular load transport, and from regularly scheduled cleansing cycles. It was also discovered that the cleaning not only removed oil and grease needed for smooth operation and protection of the plastic ball bearing which served as the opening and closing trigger for the entire caster, but also caused structure weakness in the plastic ball bearing itself.

Having identified the failures and successfully determined the causes, Colson proceed to create a comparably priced product for its customer, with improved endurance, to replace the failing cart casters. The Colson solution involved first working on the swivel. For this mechanism the team created a single-piece structure of stainless steel that integrated the lock mechanism with the top plate without welding, and included a steel ball indent mechanism, replacing the old plastic part, to control and maintain the correct swivel pressure levels. This new unit would also save man-hours and money by not requiring the application of oil or grease. The mushy plastic wheels would be replaced in the new caster with a Colson proprietary wheel combination of high-temperature nylon bonded to high-temperature non-marking neoprene, safe and solid in lifetime-drying tests considerably greater than 290 degrees F. In addition, Colson also added twin stainless steel radial bearings to the wheel with high-quality spanners to further stabilize the wheel under the hospitals' heaviest loads and to further protect the wheel from the constant wash downs.
